**Balment  
Keep**

CHARTERED SURVEYORS

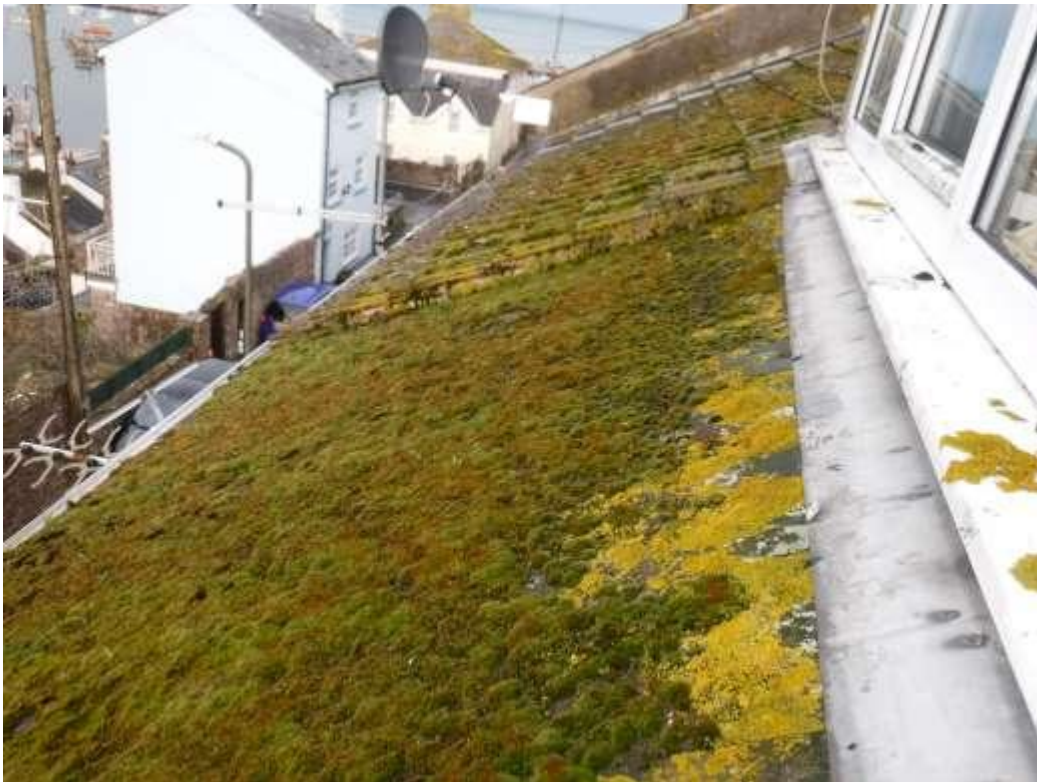
**Photo 2 The left hand part of the front roof slope is in poor condition.**

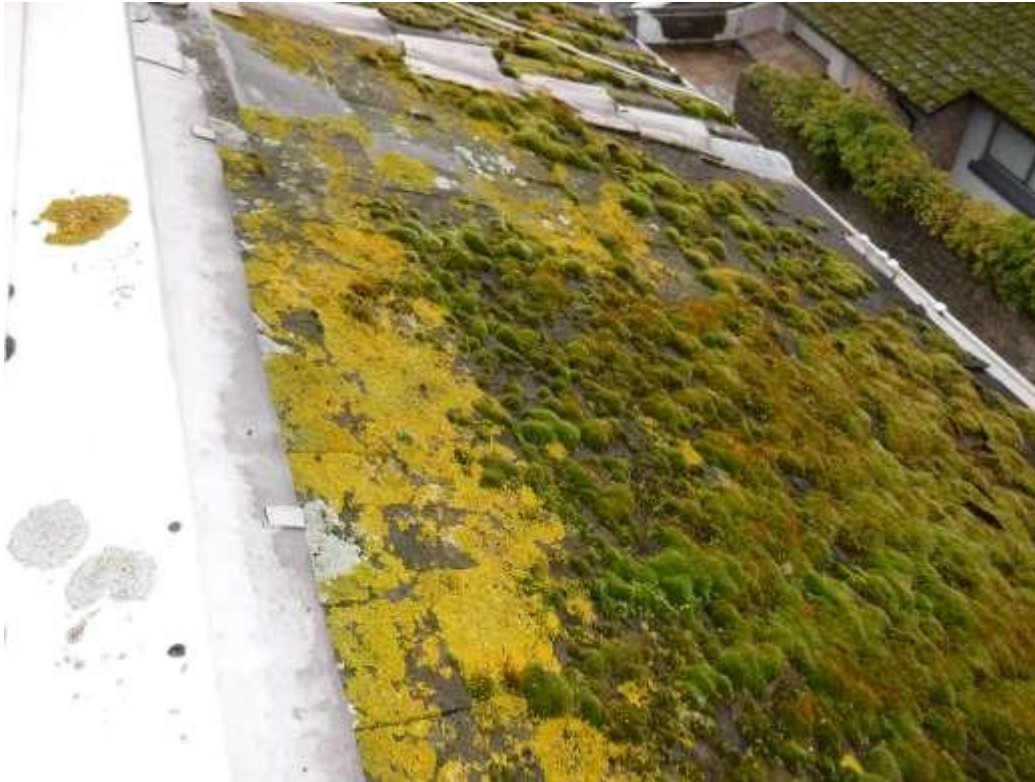
**Photo 3 The right hand part of the front roof slope is in poor condition.**

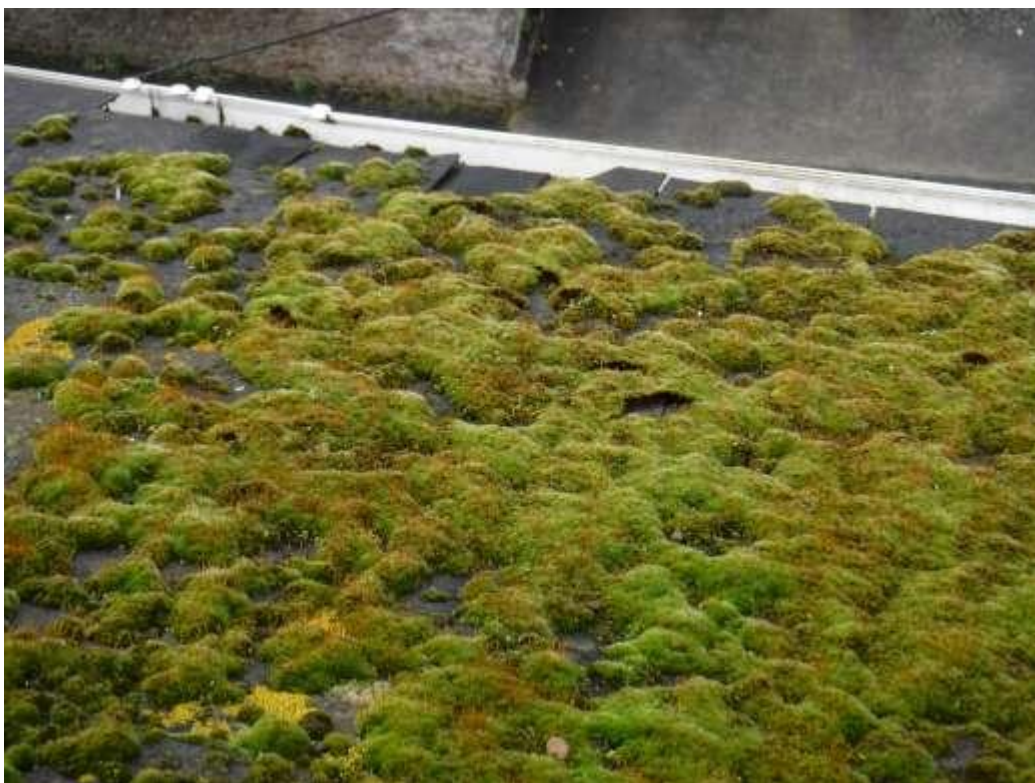
**Photo 4 Some damage noted to the slates at the front.**

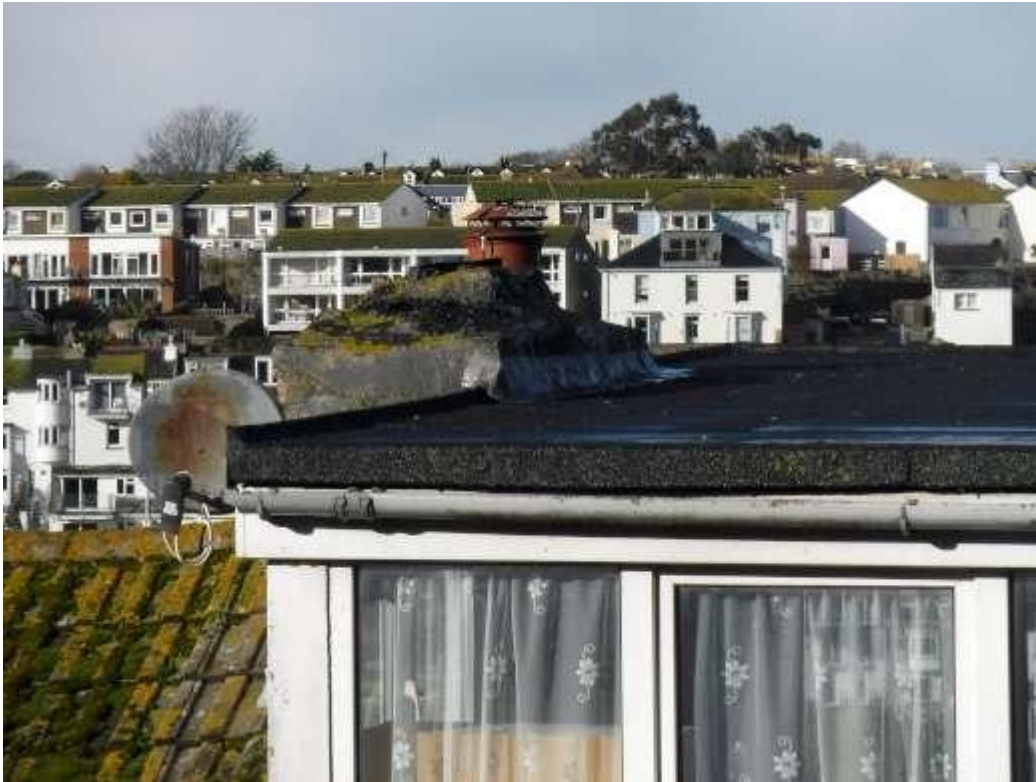
**Photo 5 The right hand chimney stack requires attention.**

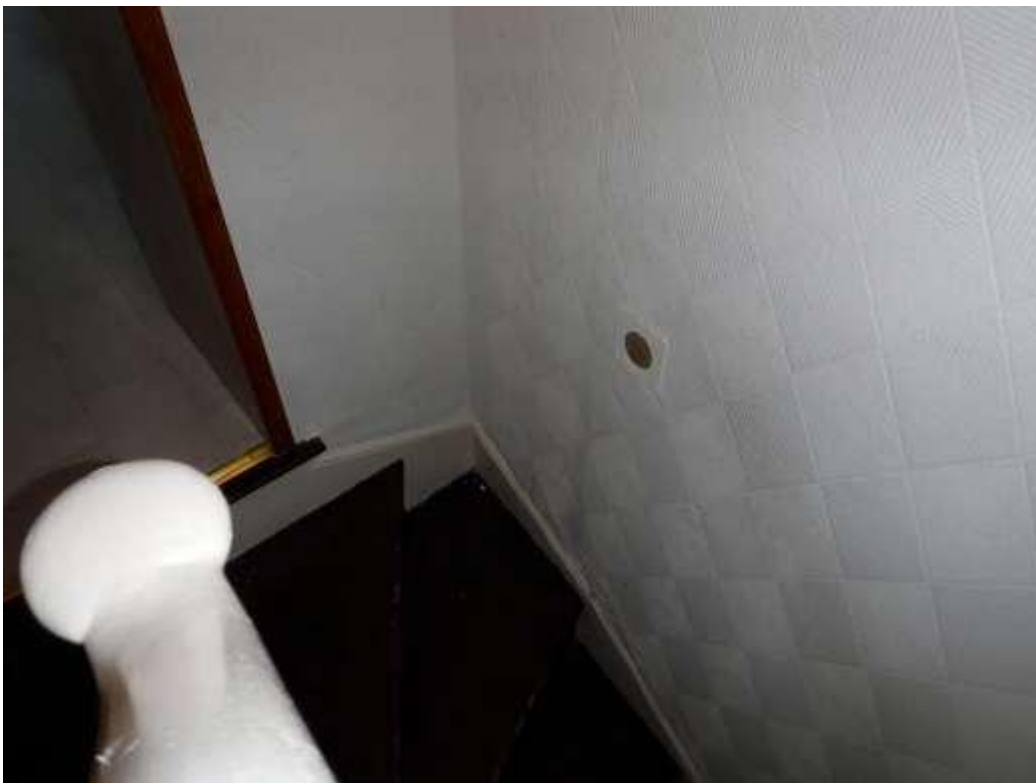
**Photo 6 Damp noted at the side of the staircase.**

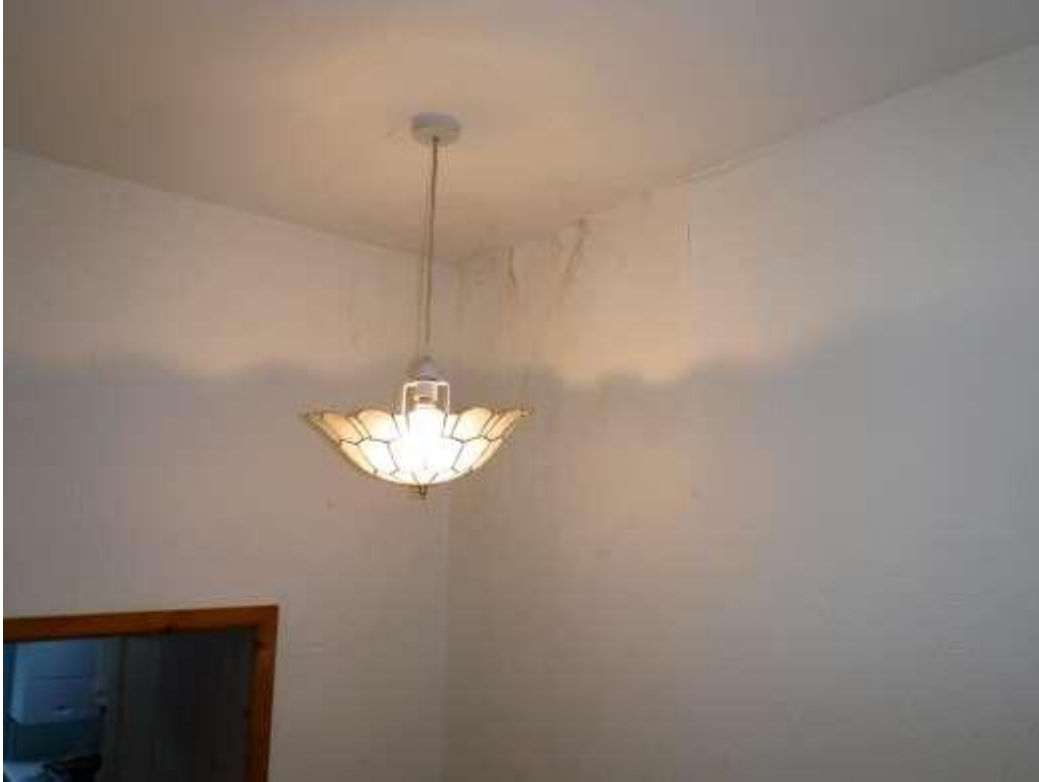
**Photo 7 Damp noted at the side of the staircase.**

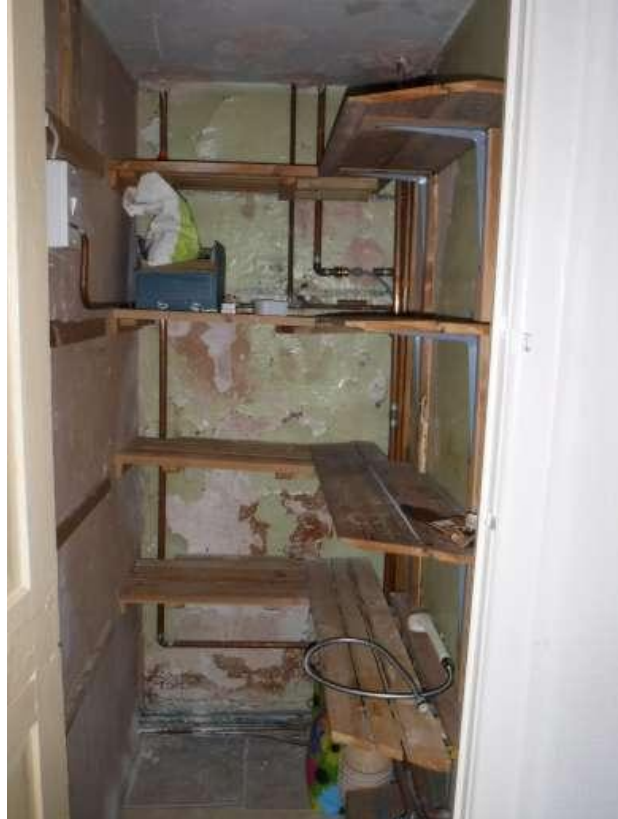
**Photo 8 Damp noted in the understairs cupboard.**

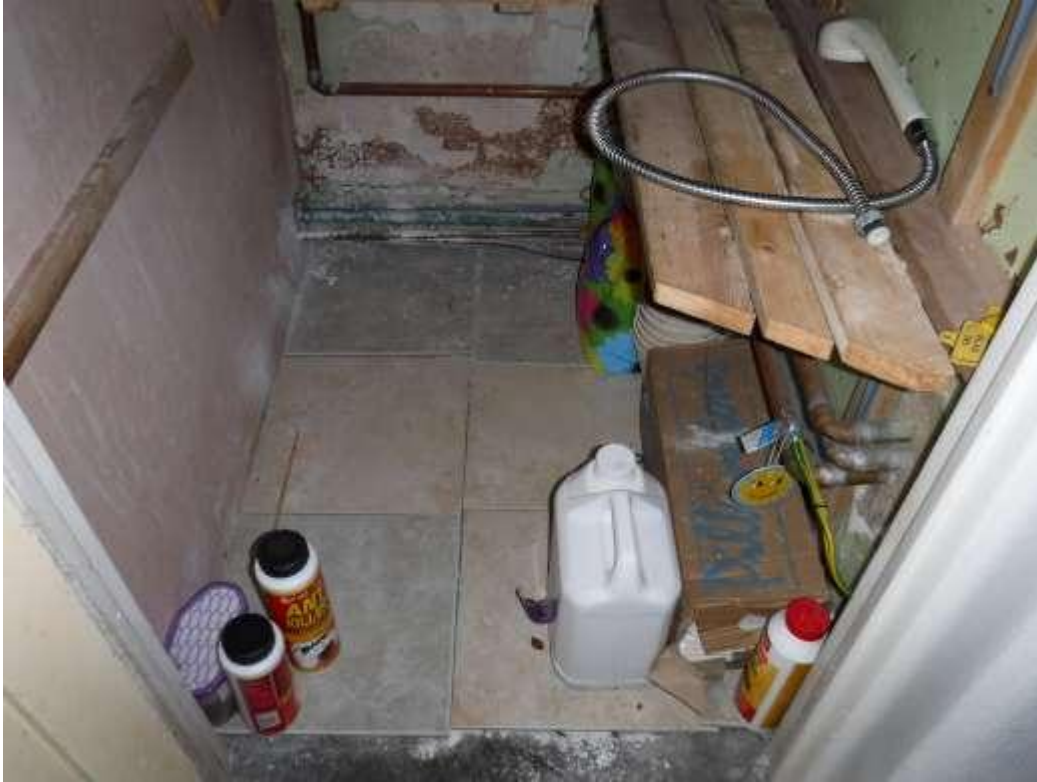
**Photo 9 Damp noted in the downstairs cupboard. These floor tiles have been loosely laid and we did note some dampness underneath.**

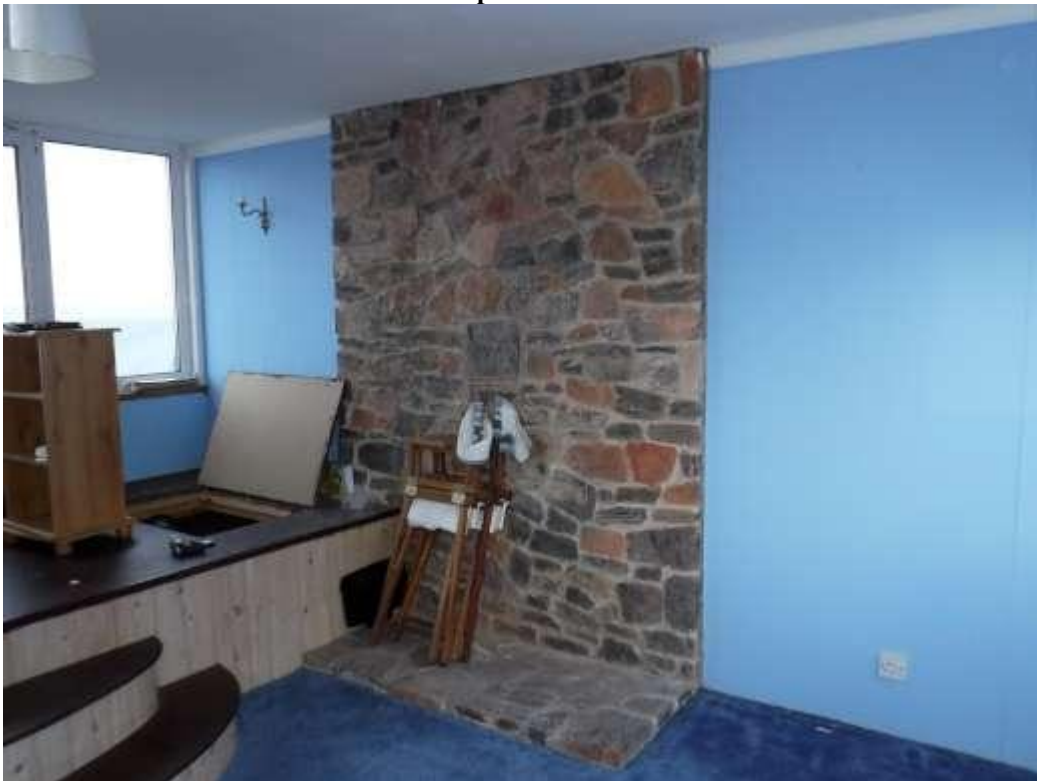
**Photo 10 The hearth on this fireplace should be removed.**

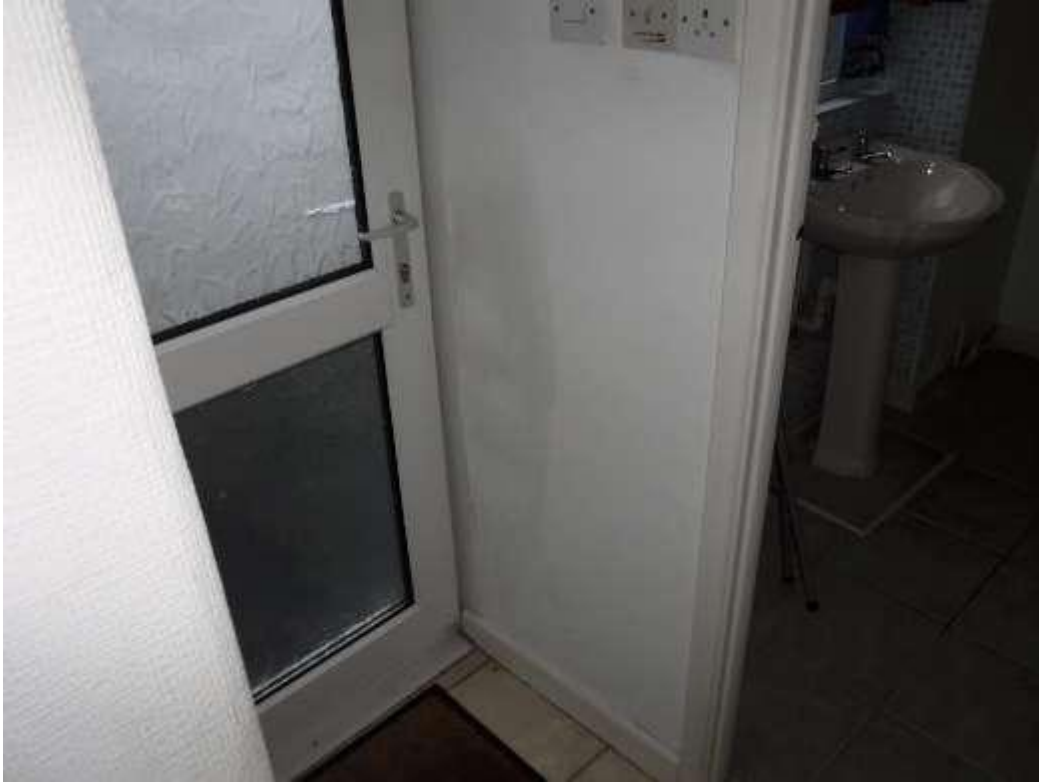
**Photo 11** Rising damp noted here. Note some of this is quite high up on the wall.

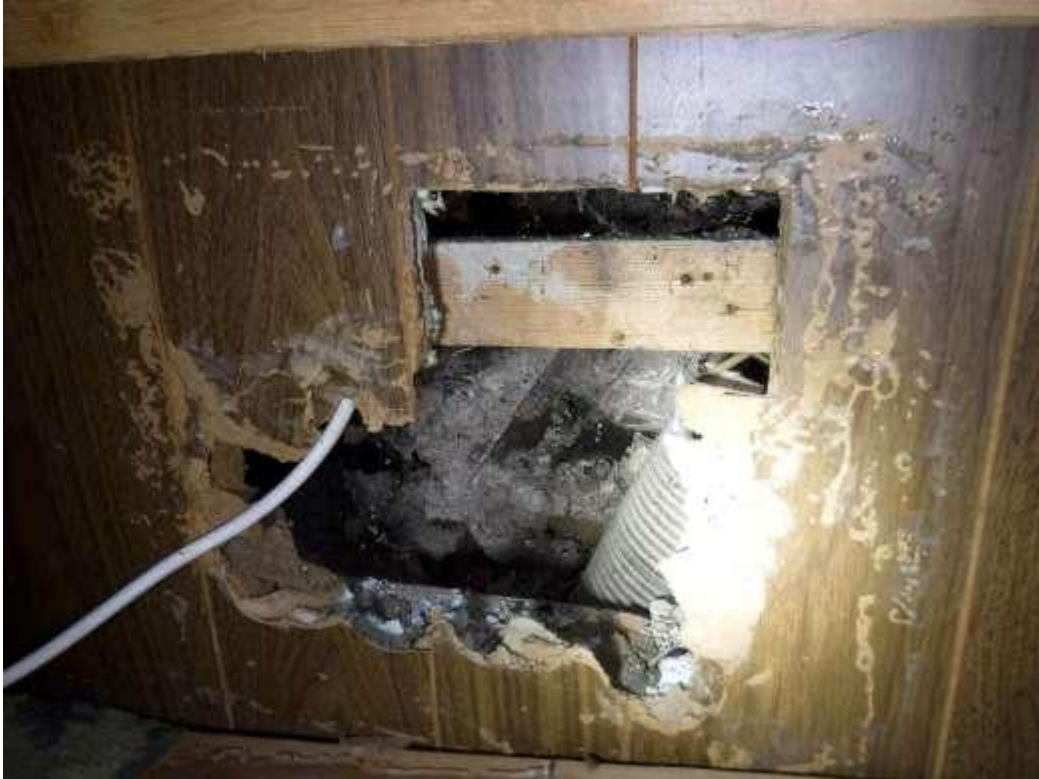
**Photo 12** Where we gained access into the timber studwork around the second floor we found no vapour barrier and no insulation.

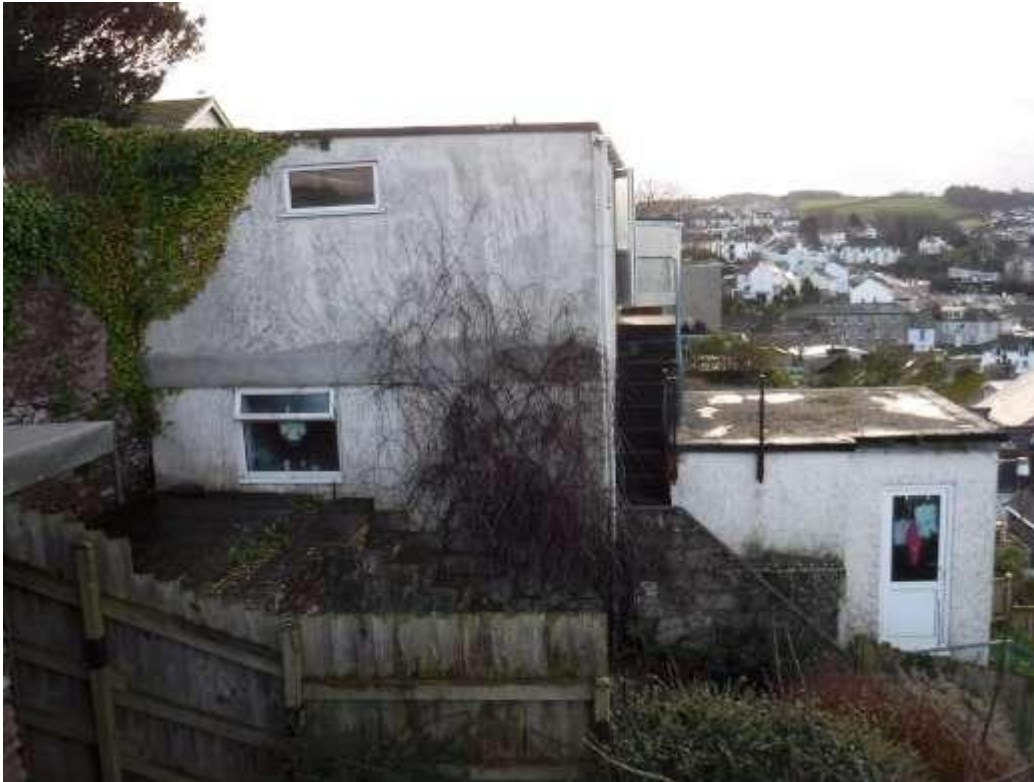
**Photo 13 Right hand side of the garage and store room below.**

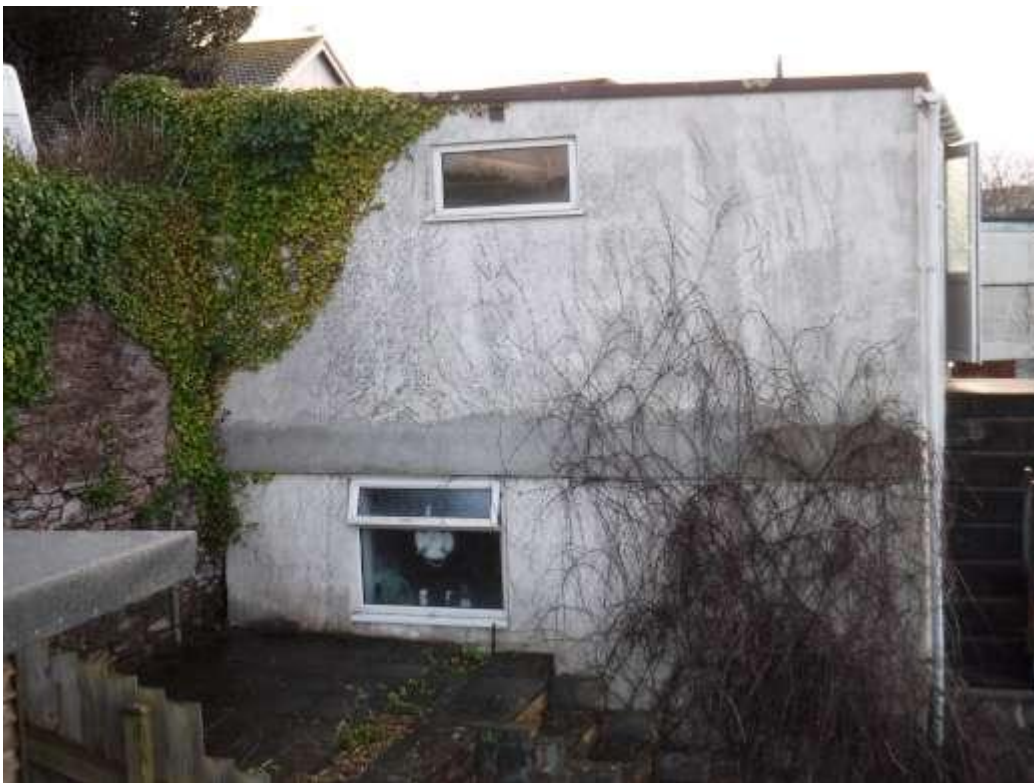
**Photo 14 Right hand elevation of the out building. Note cracking above window opening and crooked window at upper level.**

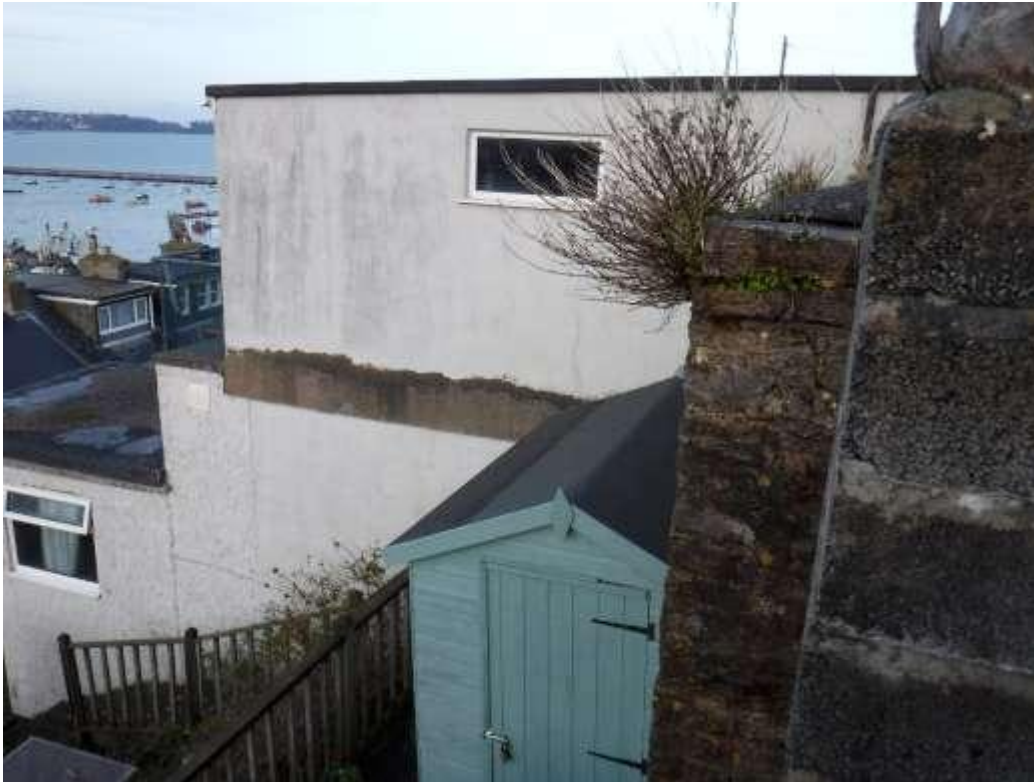
**Photo 15. Left hand elevation to the outbuilding. Note repairs have been carried out to the render in the past.**

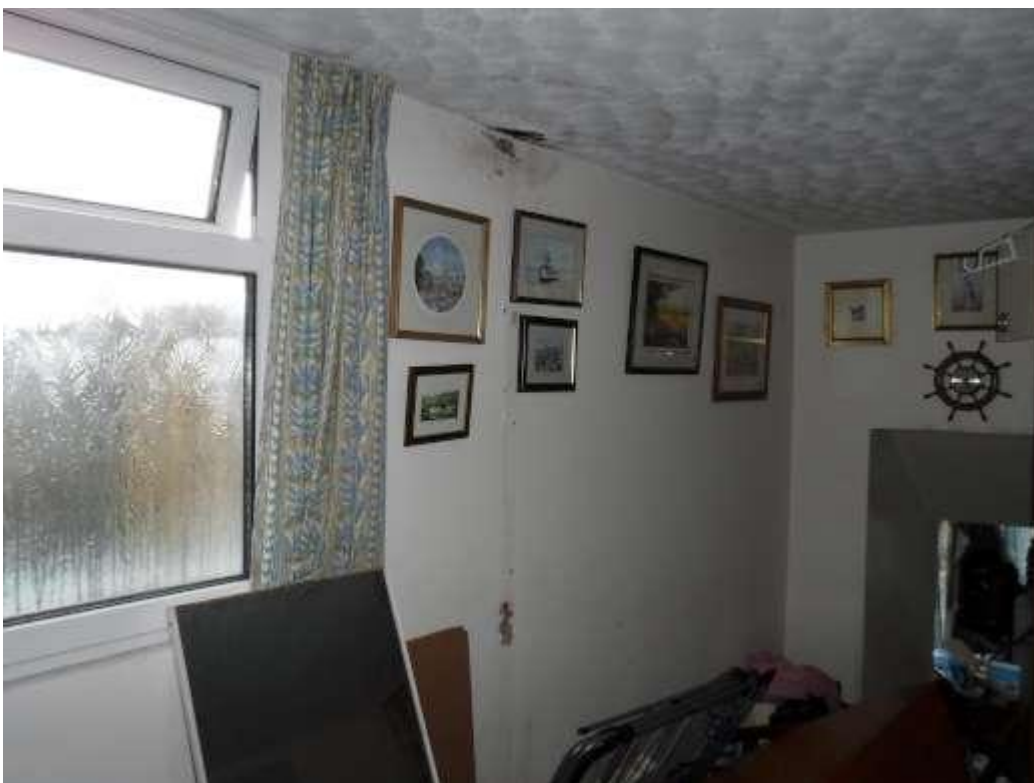
**Photo 16 Damp has been getting in through the roof here.**

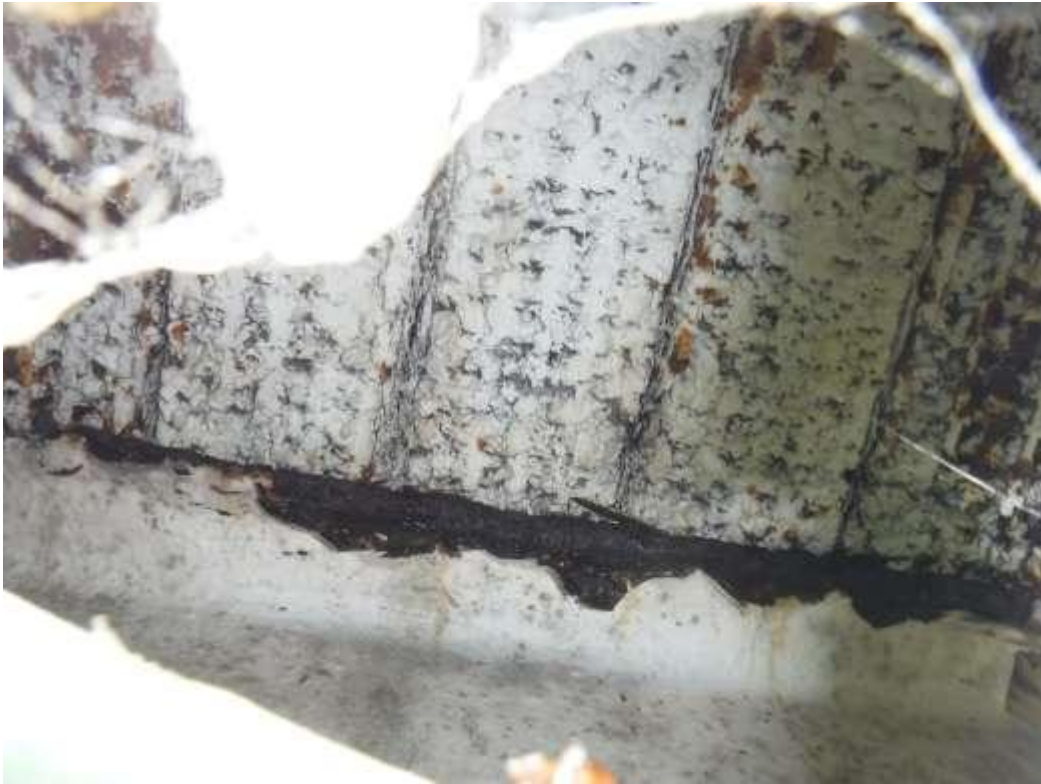
**Photo 17 Corrosion and dampness noted in the concrete floor to the garage.**

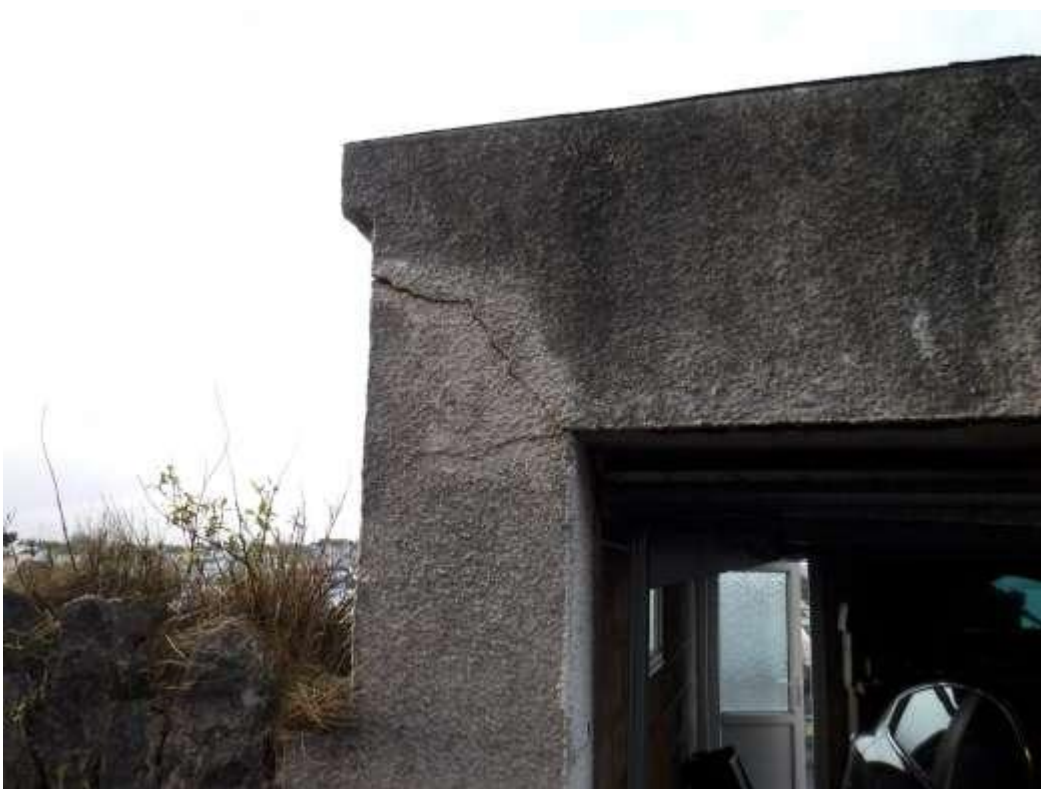
**Photo 18 Movement cracks in the garage.**

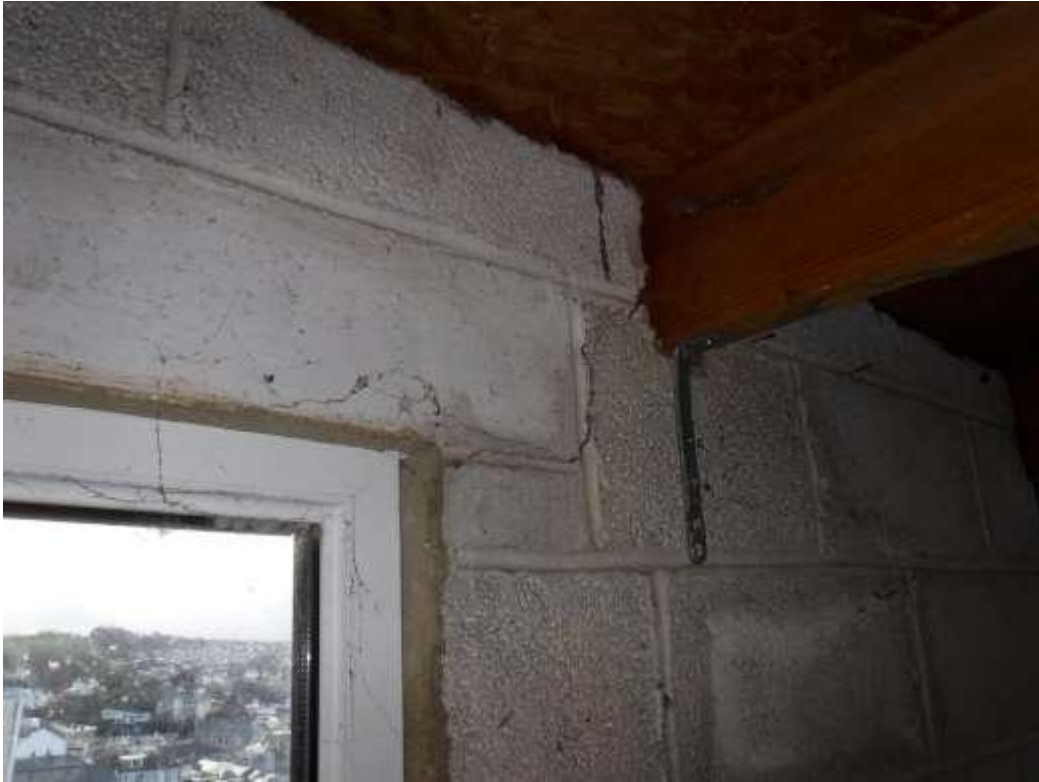
**Photo 19** Movement cracks in the garage.

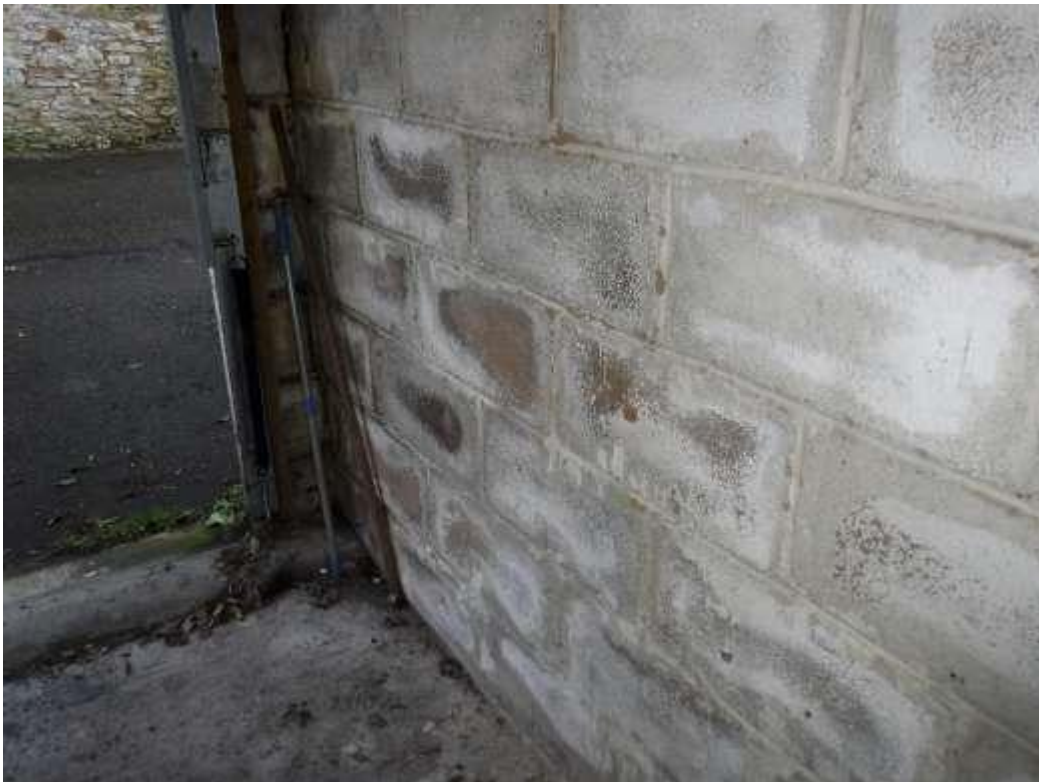
**Photo 20** Dampness noted inside the garage.

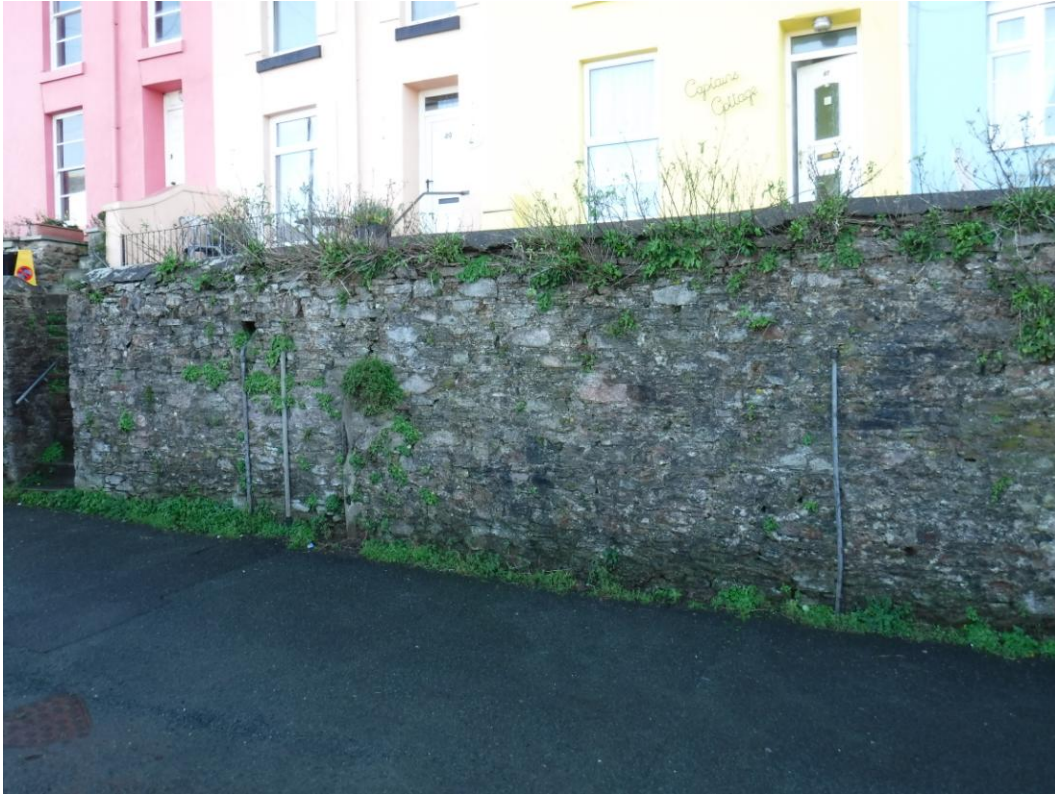
**Photo 21** The retaining wall at the front requires some general maintenance.

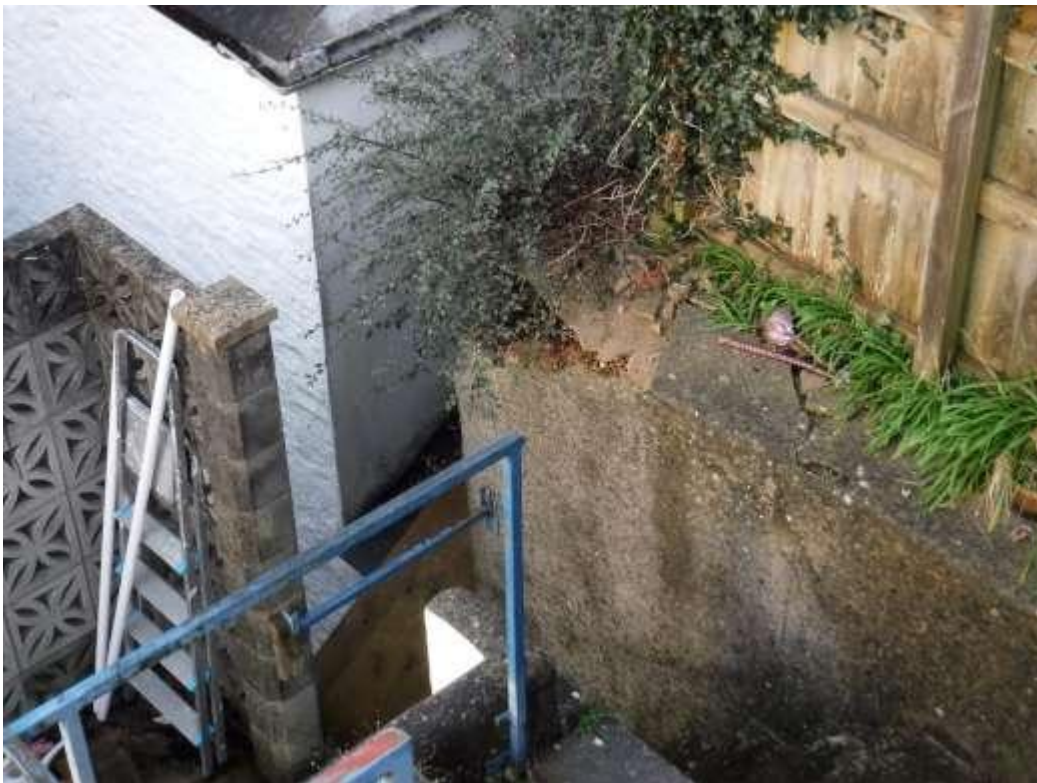
**Photo 24 The retaining walls at the rear require repair.**
