Balment Keep

BUILDING SURVEY REPORT

STRAWBERRY HILL
WHITCHURCH ROAD
TAVISTOCK
DEVON
PL19 9BD

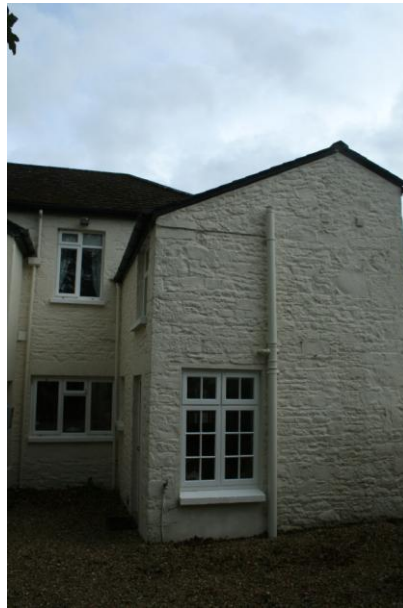
Addition 1 (Roof over Bedroom 6 and En-Suite Shower)

This roof is also a double pitched and hipped structure with a valley running between the outer roof slope of the main structure previously described to the northeast. This roof is covered as the previous roof and showed no sign of any great number of missing, cracked or broken slates.

We did note evidence of moss however to the side (northwest) elevation. Remove.

Clear out valleys at the abutment of various roof plains.

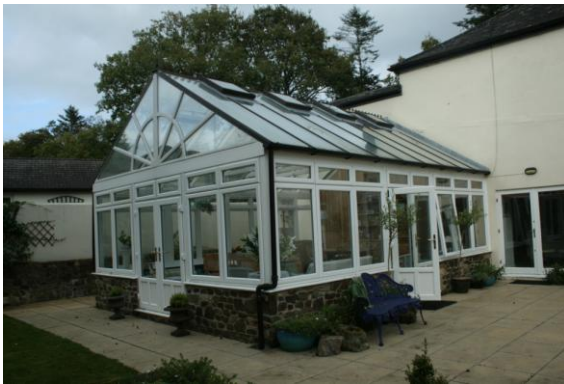
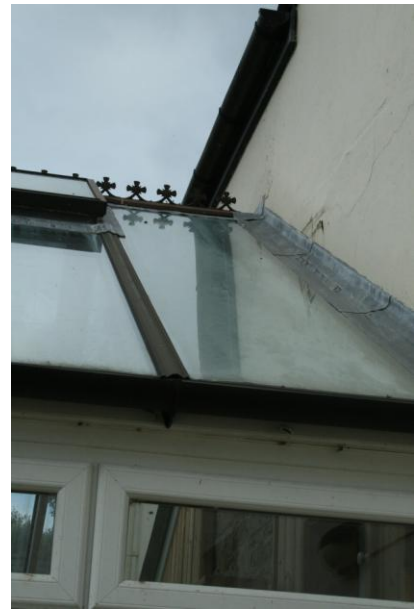
Conservatory Roof

This is a double pitched and gabled structure. There are issues we feel. Maintenance is required. The roof is finished with double glazed panels which have had a solar reflective heating applied. This has got crinkled and looks unsightly and the panel in our opinion facing the southeast garden side adjacent to the main wall of the property has blown and requires replacement. All requires sorting.

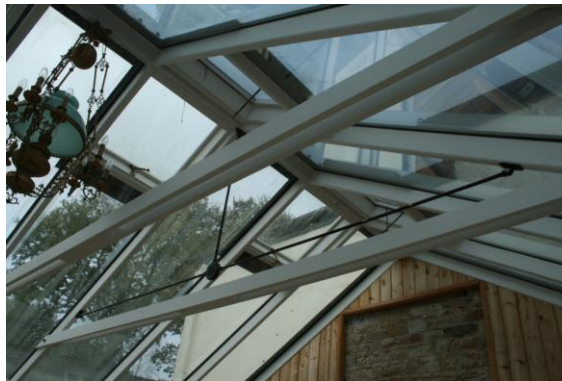
The roof has been strengthened.

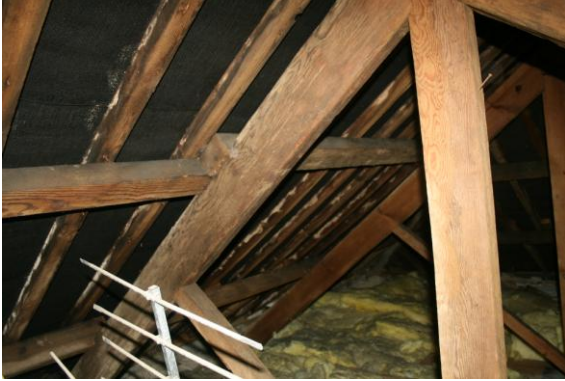
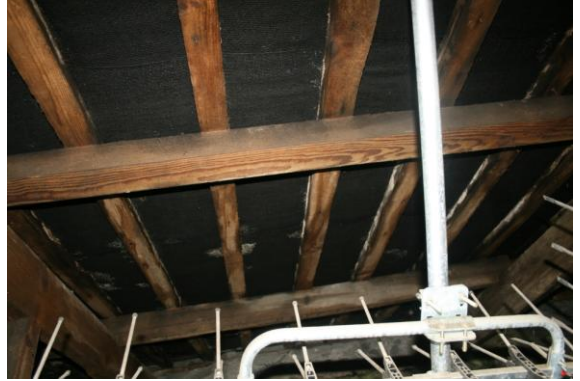
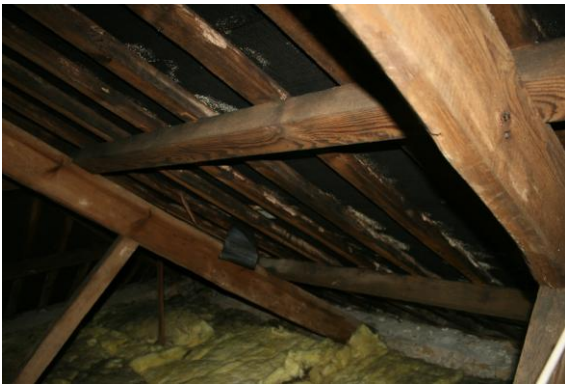
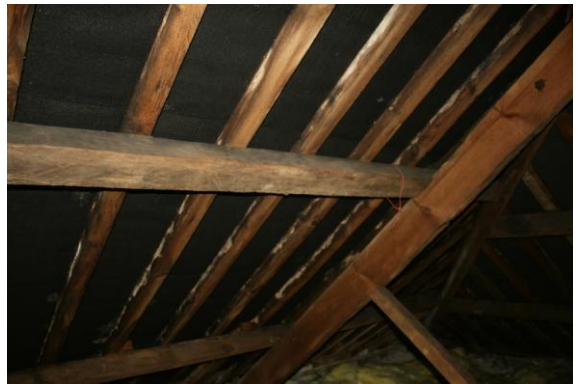
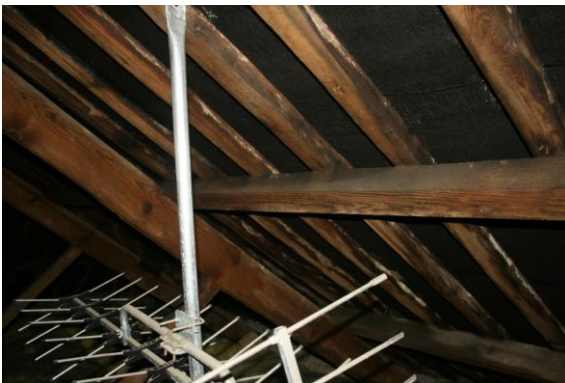
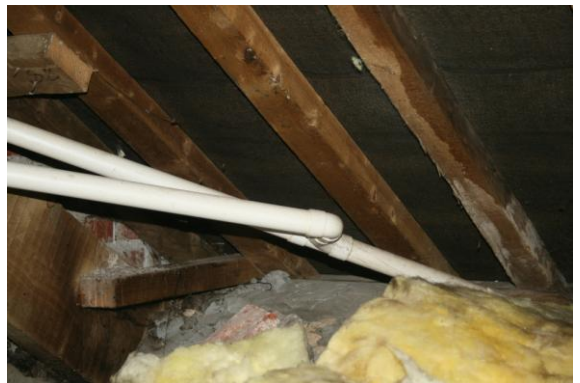
The major problem with the main roof, i.e. the twin double pitched and hipped section and the double pitched and hipped roof over Bedroom 6 and En-Suite Bathroom is a major condensation issue. We noted fairly extensive dampness to the underside of the felting, to an extensive number of rafters and to the tops surface of the fibreglass quilting. We could not inspect these whole roof areas due to access not being made possible because of the thickness of insulation. The void felt damp. This was partly caused by timber treatment work being carried out to the roof spaces only the day before. We understand from the specialist that 27 litres of water was used in the roof space in carrying out this process. This will have exacerbated the problem, but in our opinion, the matter is historic, i.e. has been going on for a considerable time and is evident to the underside of the felting and the tops surfaces of an extensive number of rafters are extremely wet and dark stained.

The cause of the condensation is due to warm moist air from the rooms below coming into contact with a cold surface (the felting). A damp unventilated situation occurs, condensation takes place with the subsequent damage resulting.

As we have discussed, the only way to overcome this problem is to install a considerable number of slate vents in all roof slopes, i.e. to the southeast side facing the garden and on the two inner roof slopes of the double pitched and gabled section and of course the roof slope facing the other side (southeast). With a through air ventilation system provided then condensation will be considerably reduced, if not eliminated.

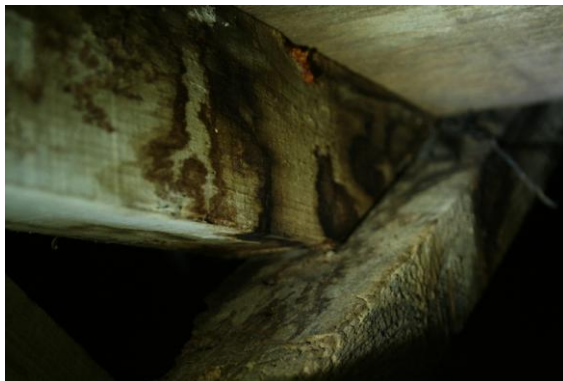
Rainwater ingress noted to roof void over Bedroom 6. Valley issues and also rear hip rafters were wet. Check hips externally and valley gutter.

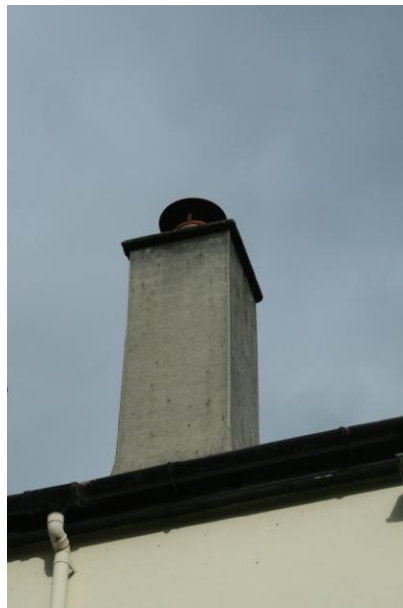
There is one chimney stack. This is located to the rear (southwest) elevation and this takes the flue from the open fire in the main sitting room. The stack above roof level is of block, stone or brickwork and has relatively newly cement and sand rendered elevations. Above roof level there was no sign of any cracking, leaning or bulging.

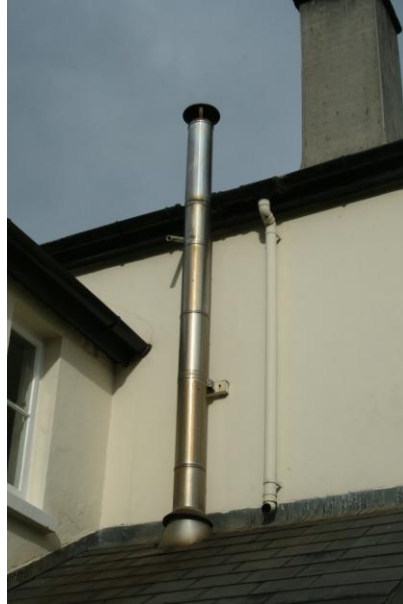
There is a stainless steel flue, also to the same elevation, which takes the flue from the oil fired boiler located in the boiler room. Also sound. No sign of any defects.

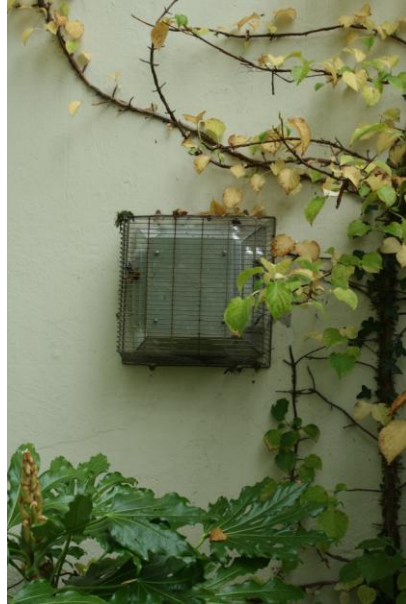
- (i) We noted hollow render to the left hand side of the main front door adjacent to the balanced flue which exits this wall from the gas fire in the library.

(vii) We refer to our remarks concerning hollow patches to the external rendering. Some re-rendering works have been undertaken by the present vendor, but due to age, hollowness to some rendered surfaces was noted and this will require hacking off and renewing in time.

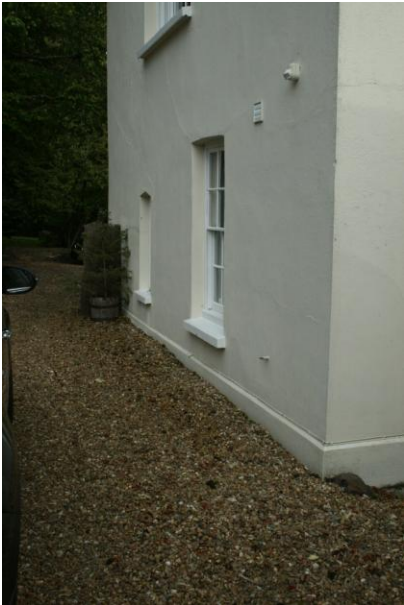
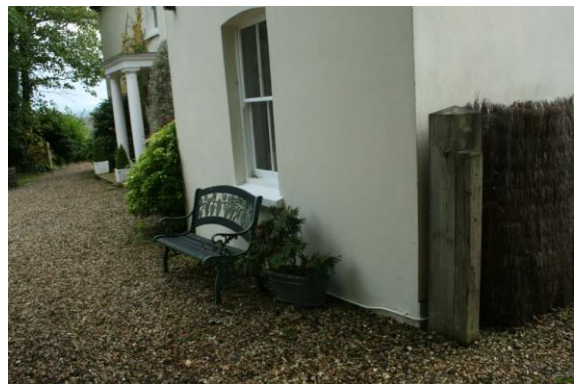
(iii) To the front (northeast) elevation we noted that this wall of the office and dining room has the external ground level higher than the internal finished floor level. This could and probably has caused a damp ingress problem in the past, although no serious damp was noted internally at the time of inspection. We would think it prudent however to reduce this external ground level below internal finished floor level. Similar remarks apply to the side (northwest) elevation.

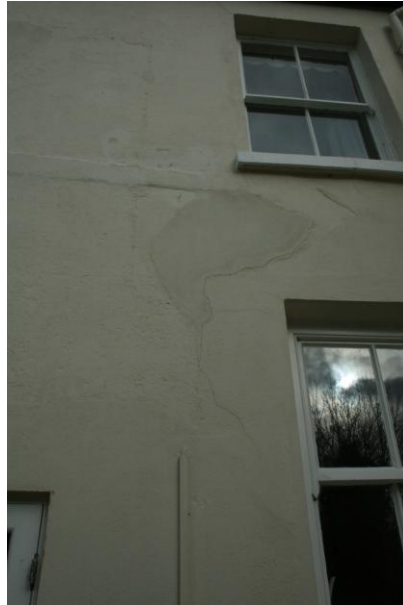
(v) Hollow render was noted to the rear (southwest) elevation to the area of wall above the kitchen/breakfast room, i.e. Bedroom 4 and 5.

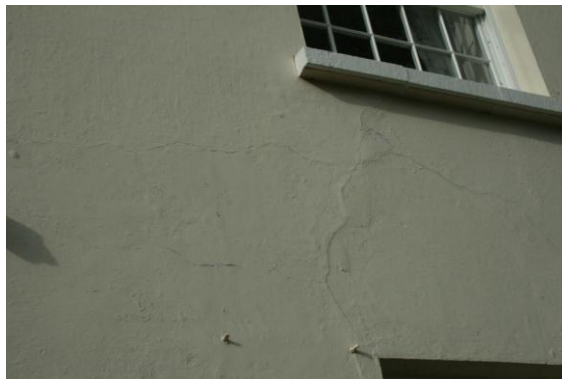
(vii) We also noted a crack on the side (southeast) elevation (facing the garden) between the head of the library window and the cill of the window in bedroom 2. Again, hack out and renew prior to redecoration.

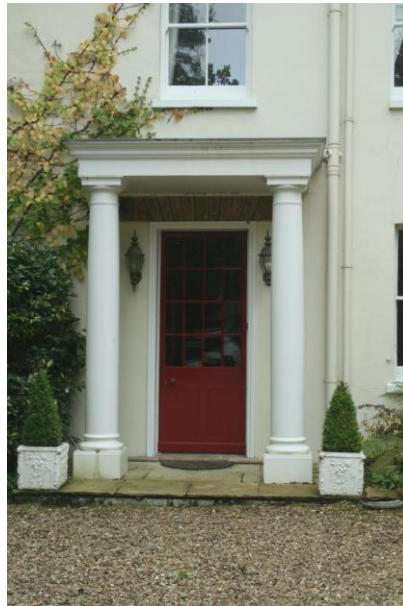
A new 'Portico' to the front entrance has been built. Of metal construction, painted and with a flat, probably lead lined covering. Sound.

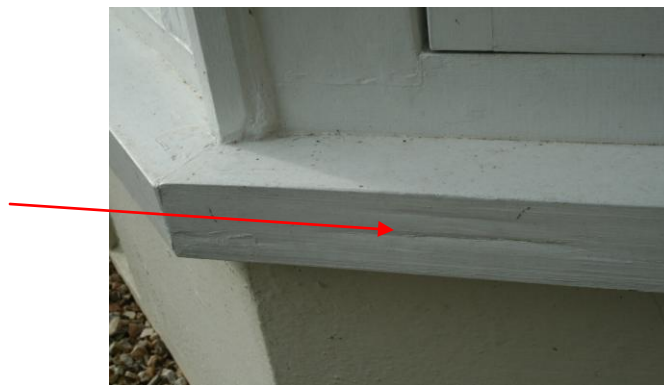
Wood rot noted to a ground floor window cill.

It appears that the older windows that remain have been overhauled whilst the older windows in need of replacement indeed have been. We examined the windows where possible and the only serious wood rot that was noted was the window cill to one side of the replaced bay windows in the sitting room. Cut out and renew defective parts. Prior to redecoration, which must be carried out in 3 to 4 years time, all window sections must be closely examined and any wet rotten parts, which there are bound to be, will have to be cut out and replaced as part of a maintenance programme. This will not be inexpensive due to the number of windows and to the fact that they are of timber.

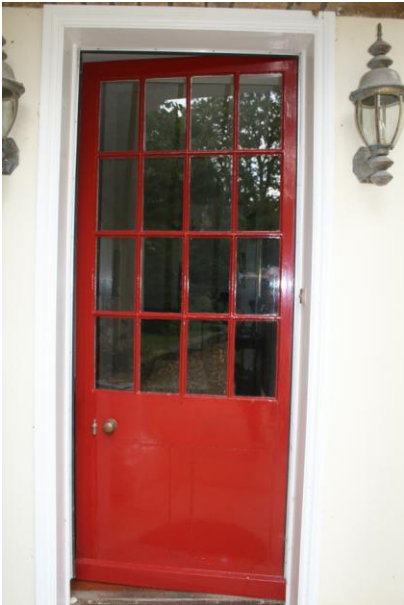
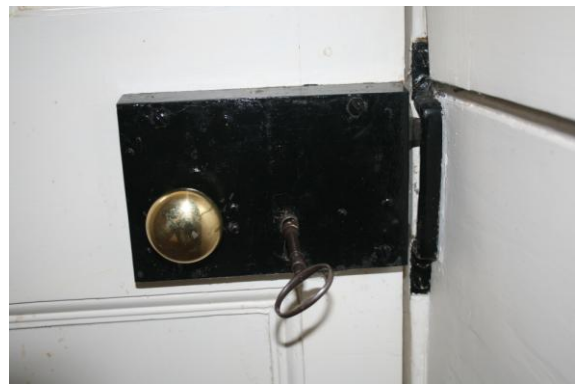
Main (front)

Hardwood (painted) $\frac{3}{4}$ small paned. Sound. Very old and probably original rim lock and key. Still working!

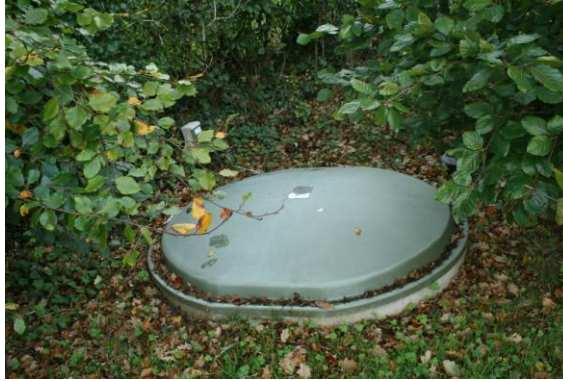
The foul water system is connected to a septic tank. It is a Klargestor with an electric masticator. The Klargestor was put in place in 2002/3 and is shared with the adjacent house, "The Stables". All costs are shared which include the emptying from time to time and this was last carried out earlier this year (SCG Drainage 01752 847737). A new motor and gear box was inserted at a cost of £185 in 2016 to the moving section.

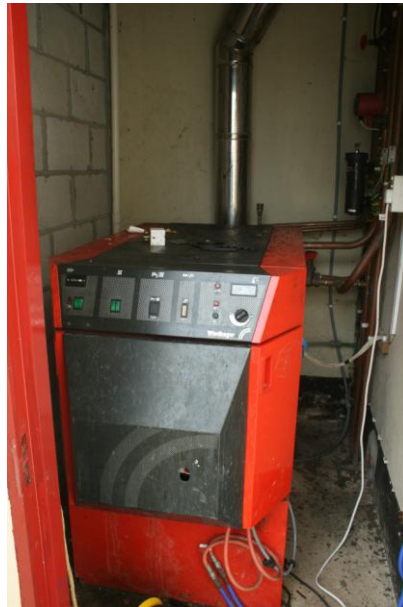
There is a floor mounted Windhager oil fired substantial boiler located in the boiler house. We understand that this unit was put in place long before the present vendor took occupation and it may be nearing the end of its life. We would strongly recommend that it be tested by a suitably qualified specialist boiler engineer. A firm we would recommend would be D B Heating, Atlas House, Plymouth Road, Tavistock (01822 611300). The boiler serves a wet radiator system and also heats the domestic water which is stored within the large hot water storage cylinder.

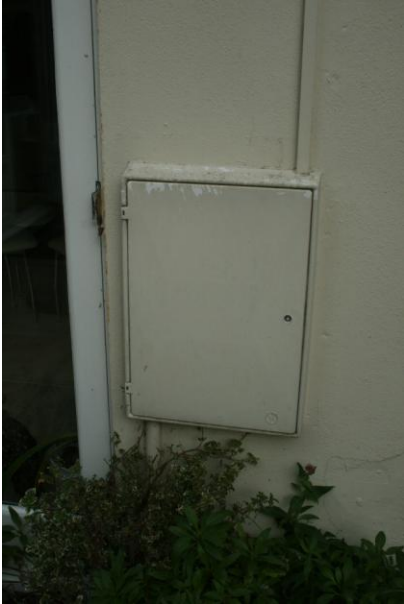
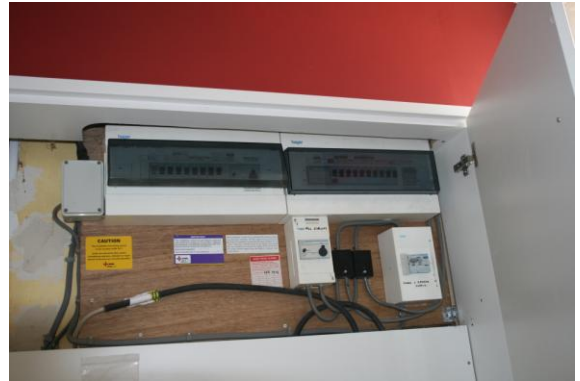
9.08 Electrical System

Mains overhead supply. External meter. We understand that in the late 1990s the property was re-wired, although we have seen no evidence of this. There are new MCB fuse boxes. There appeared to be a generally adequate number of lighting and power points throughout.

However, due to the age of the installation we most strongly recommend that the installation be tested by a suitably qualified NICEIC registered electrician prior to contract and would recommend a Mr Adrian Timms, Newlands Court, Powl Cross, Bridestowe EX20 4QE (01837 861663 / 07836 668796). We are concerned about the earth bonding. Regulations have changed recently. Sort.

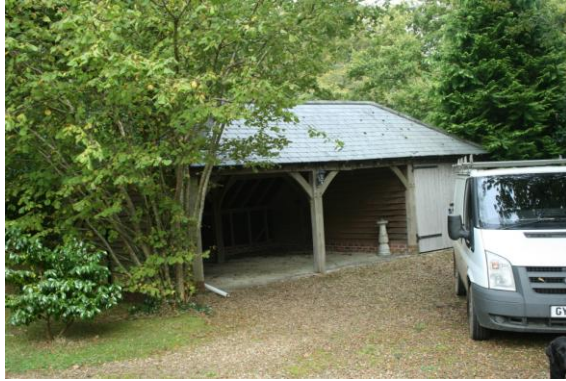
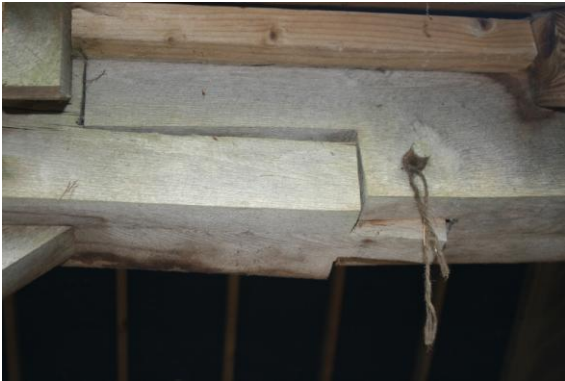
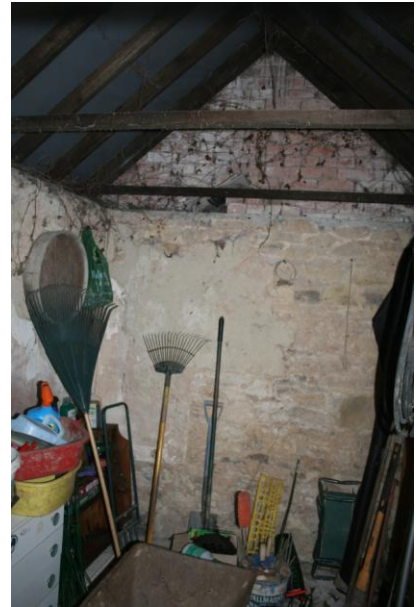
10.01 Garage/Parking

The property has an attractive green oak “Hamlet” open car port with two spaces and an attached shed. There is a dwarf brickwork base, DPC, concrete floor and oak framing and boarding. The roof is double pitched and gabled and covered with natural slates. The condition of this building is adequate for use and purpose. There have been some movements between the structural members however. Keep a check, but no damage appears to have resulted. Probably the oak drying out over a considerable period.

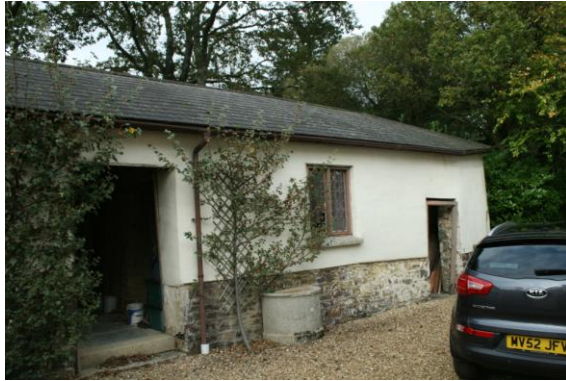
Double pitched and hipped roof covered with natural slates. The walls are of solid masonry or cob. Externally part rendered. Fairly extensive cracking to front wall. All openings are left

exposed, i.e. there are no doors in place or windows. The floor is of natural stone cobbling or earth. An extensive amount of money is required to be spent on this outbuilding for it to be of use, although it was found to be fairly dry at the time of inspection.
