Balment Keep

BUILDING SURVEY REPORT

STRAWBERRY HILL
WHITCHURCH ROAD
TAVISTOCK
DEVON
PL19 9BD

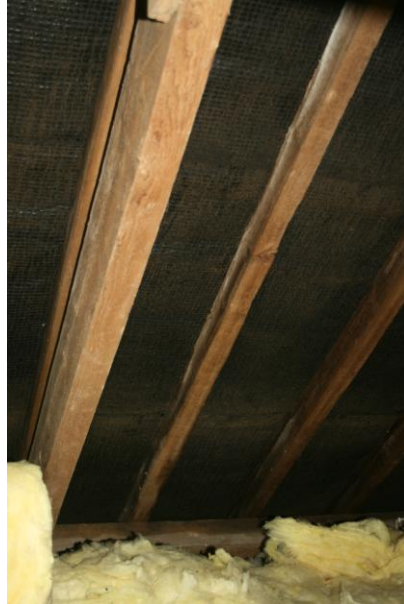
The major problem with the main roof, i.e. the twin double pitched and hipped section and the double pitched and hipped roof over Bedroom 6 and En-Suite Bathroom is a major condensation issue. We noted fairly extensive dampness to the underside of the felting, to an extensive number of rafters and to the tops surface of the fibreglass quilting. We could not inspect these whole roof areas due to access not being made possible because of the thickness of insulation. The void felt damp. This was partly caused by timber treatment work being carried out to the roof spaces only the day before. We understand from the specialist that 27 litres of water was used in the roof space in carrying out this process. This will have exacerbated the problem, but in our opinion, the matter is historic, i.e. has been going on for a considerable time and is evident to the underside of the felting and the tops surfaces of an extensive number of rafters are extremely wet and dark stained.

The cause of the condensation is due to warm moist air from the rooms below coming into contact with a cold surface (the felting). A damp unventilated situation occurs, condensation takes place with the subsequent damage resulting.

As we have discussed, the only way to overcome this problem is to install a considerable number of slate vents in all roof slopes, i.e. to the southeast side facing the garden and on the two inner roof slopes of the double pitched and gabled section and of course the roof slope facing the other side (southeast). With a through air ventilation system provided then condensation will be considerably reduced, if not eliminated.

We would also install a Positive Air system. This information can be obtained from southwestventilation.co.uk (01326 727101). See Drimaster- Echo Range ventilation system.

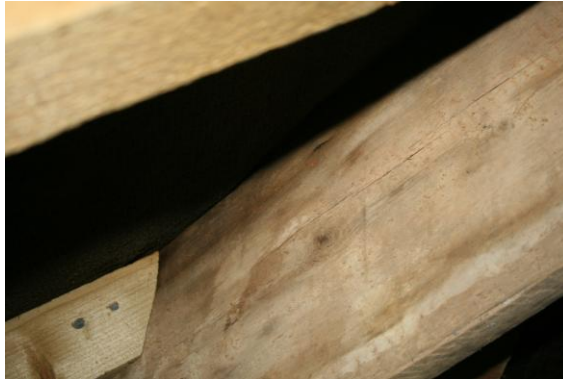
Rainwater ingress noted to roof void over Bedroom 6. Valley issues and also rear hip rafters were wet. Check hips externally and valley gutter.

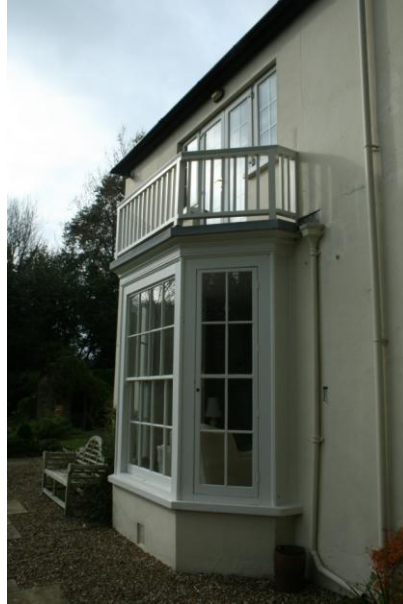
Wood rot noted to a ground floor window cill.

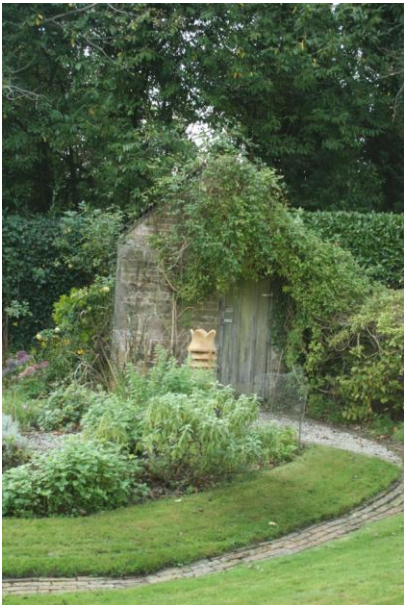
Privy

Stone built and slated. Dry internally. Timber door.
